**Assessment of Aquatic Ecosystem
Restoration Projects**

1999 – 2014

**North Fork Gunnison River
Delta County, CO**

December 2014

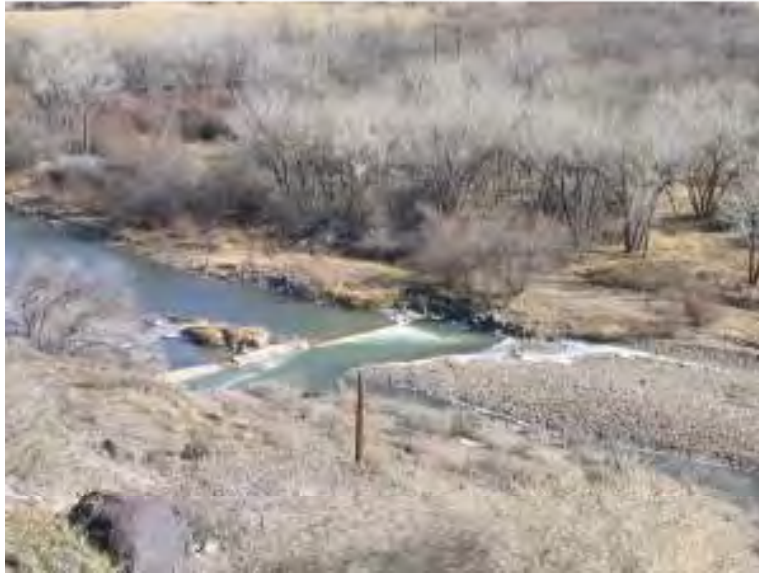
Photo 3. Chipeta Dam Prior to Removal, 2006

Poor condition ratings were documented for aquatic habitat barriers (1/20, parameter 1), channel alteration (2/20, parameter 5), and channel sinuosity (1/20, parameter 6) prior to dam removal. Clearly the dam provided a major blockage for fish passage, and the channel was heavily altered and channelized while the dam was in operation. Marginal ratings were earned for in-stream categories such as aquatic structure as cover (9/20, parameter 2) and velocity/depth regimes (9/20, parameter 3). The velocity/depth regime score was likely also related to the dam's presence, as dams are known and designed to alter and regulate flows. However, flow continuity (parameter 4) was maintained while the dam was present, so an optimal rating of 18/20 was achieved for that metric.

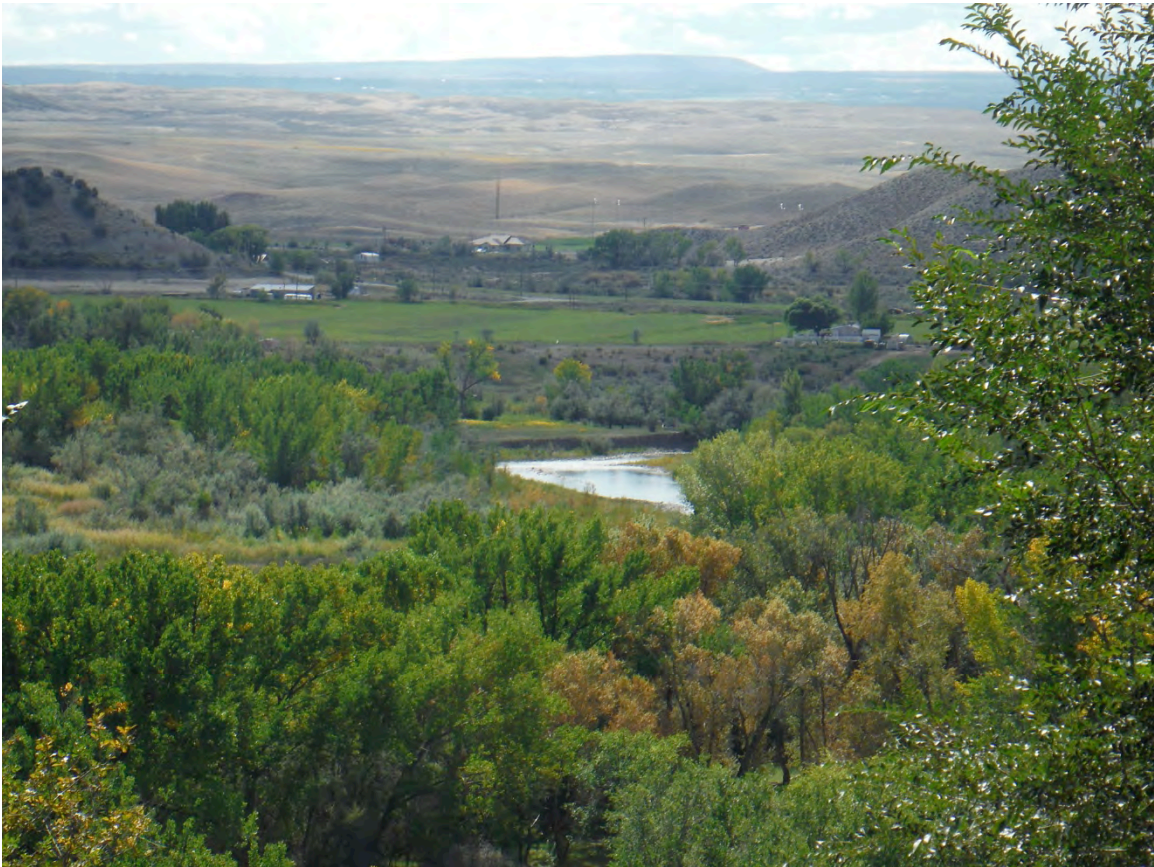
Photo 15. Waters-Carpenter Site, 2014

Despite the project recommendations in the Crane (1997) and USACE (2007) reports, it appears that a restoration project does not need to be performed at this location; the bank, while vertical, is quite stable and has not eroded significantly for almost two decades over a range of flow conditions. No recommendations for future projects at this location are suggested at this time.

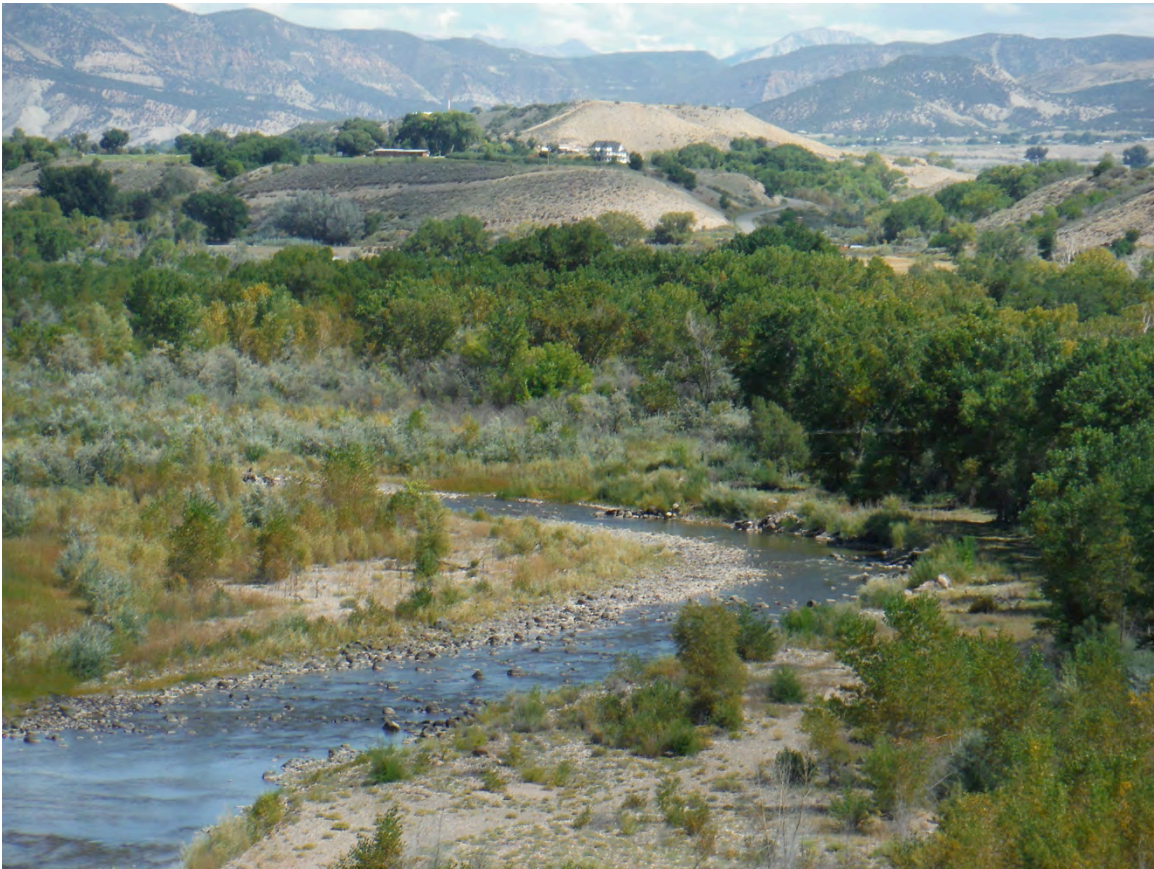
Photo 22. Upper Curry Restoration Site, 2014

All of the post-project habitat quality assessment criteria achieved suboptimal or optimal condition category ratings (Table 7) at the Upper Curry restoration site (Appendix B, Photo 22). Structural and hydrologic improvements such as increasing sinuosity, reducing grade, creating riffle-pool sequencing within the channel, and installing large boulders and J-hook structures contributed to high scores for aquatic structure as cover (13/20, parameter 2), velocity/depth regimes (17/20, parameter 3), flow continuity (16/20, parameter 4), channel alteration (14/20, parameter 5), channel sinuosity (16/20, parameter 6), and bank stability (18/20, parameter 7). Ratings for vegetation-related parameters (parameters 8-11) also fared extremely well as a result of cottonwood and willow plantings, restricted grazing, and development of abandoned channels into wetland areas. In particular, riparian vegetation cover (parameter 8), riparian vegetation structural diversity (parameter 9), and wetland area and function (parameter 11) criteria all achieved optimal scores of 18/20.

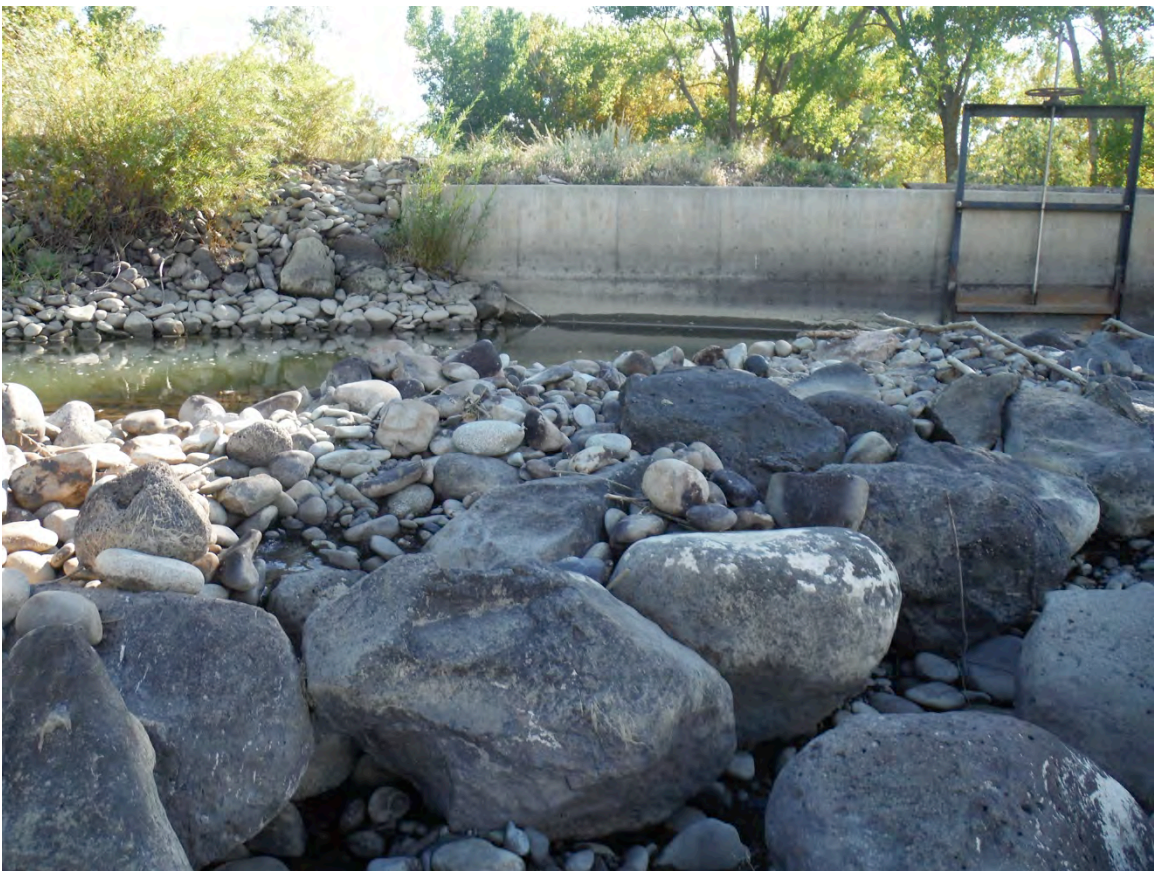
Photo 31. Short Ditch, 2014

Very minor improvements were observed in habitat quality as a result of this project, largely due to the fact that instead of leaving the diversion structure alone, the river adjacent to structure is still being consistently bulldozed, rendering the restoration

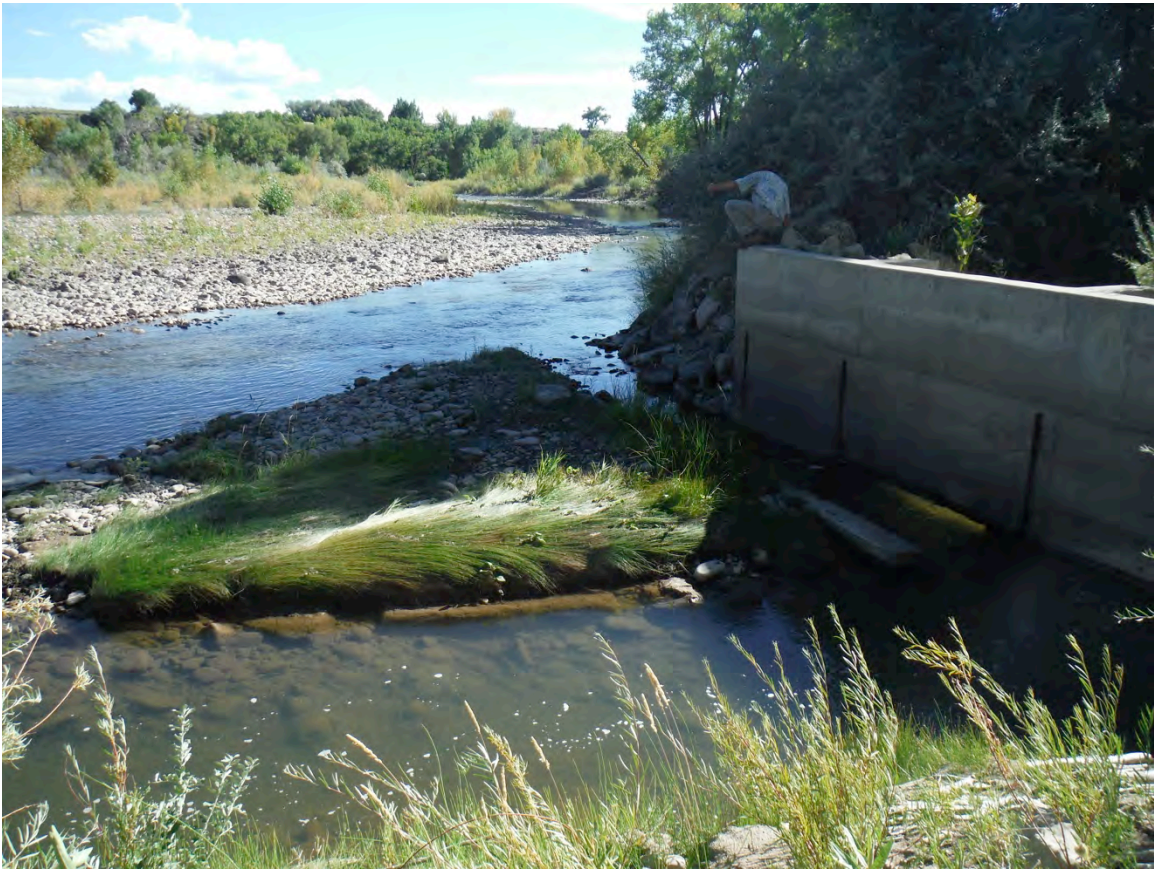
Photo 32. Sheppard-Wilmot Ditch, 2014

Although the diversion ditch has held up relatively well over time, landowners fortify the diversion structure with carpet, hay bales, and other materials in an attempt to increase flows to the ditch during low flow periods. A recommendation for a future project is to extend the Sheppard-Wilmot Ditch diversion structure further into the main channel to make it more sustainable over the long term, so that landowners do not need to improvise by adding outside materials to extend the diversion. A slide gate valve at the headwall could improve manageability of maintenance operations. The J-hook flow structure downstream of the diversion could also be rebuilt as part of this potential project.

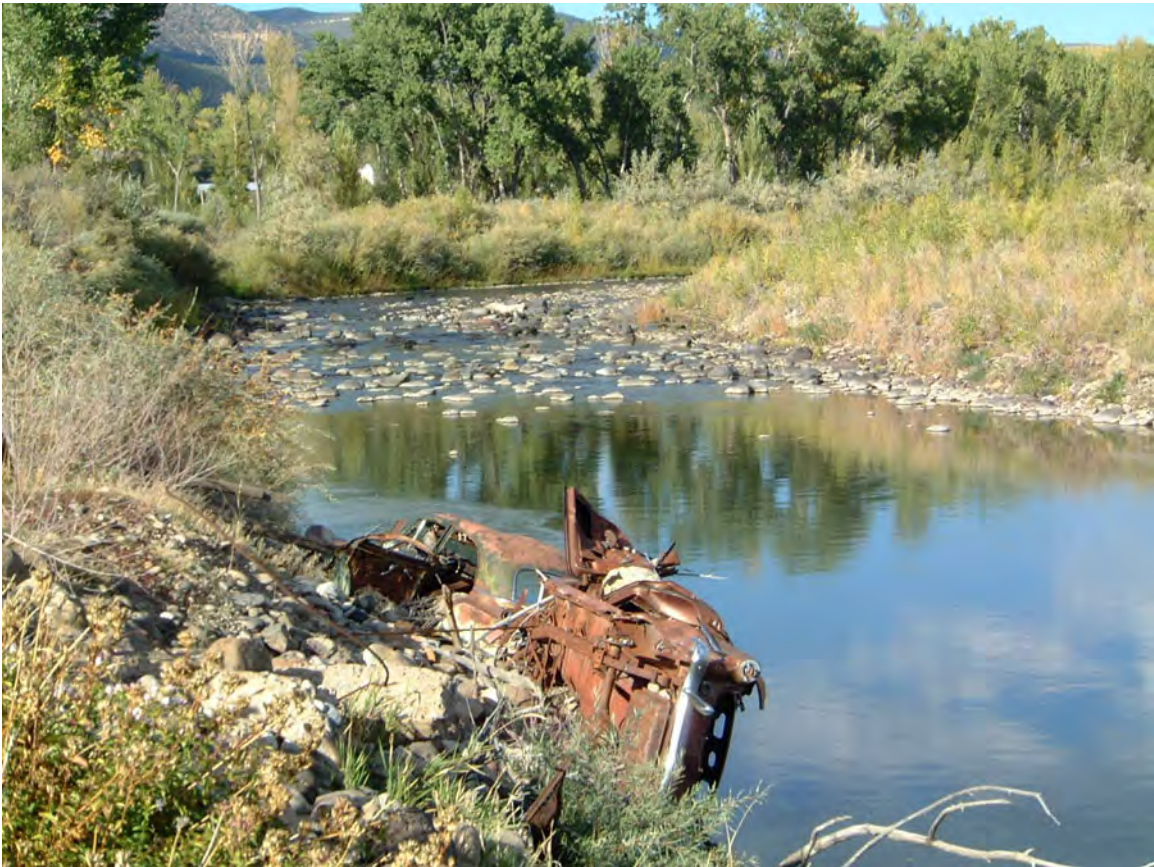
Photo 34. Bank on Monitor Ditch Site Prior to Construction

Pre-project habitat quality scores are presented in Table 13. Due to annual temporary push-up dam construction, this site earned low scores for flow continuity (6/20, parameter 4), channel alteration (3/20, parameter 5), left bank stability (2/10, parameter 7), and left bank riparian vegetation structural diversity (5/10, parameter 9). Habitat quality ratings for channel sinuosity (2/20, parameter 6) and wetland area and function (1/20, parameter 11) were in the poor condition category as well. Remaining habitat quality criteria ranked in the suboptimal to optimal range.

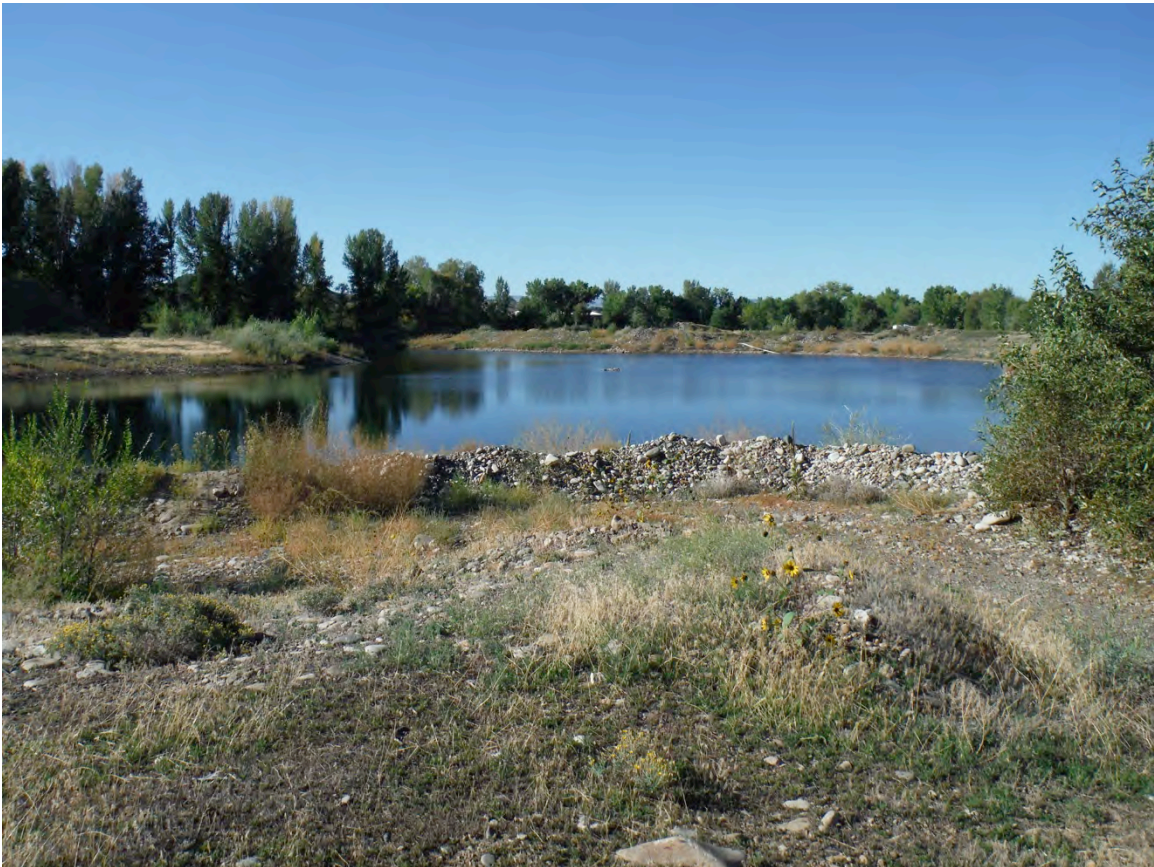
Photo 37. Farnsworth In-Stream Gravel Pit, 2014

The remaining habitat quality criteria achieved ratings in the poor condition category. Historical channel-straightening activities have resulted in poor scores for channel alteration (3/20, parameter 5) and channel sinuosity (2/20, parameter 6). Bulldozing and in-stream mining have increased the width-to-depth ratio in this entire reach, altering flow regimes and compromising flow continuity in areas. Subsequently, velocity-depth regimes (4/20, parameter 3) and flow continuity (4/20, parameter 4) earned low scores. This section of the North Fork does not contain much structure such as snags, boulders, large wood, or undercut banks that aquatic biota could use as cover, resulting in a poor score for aquatic structure as cover (3/20, parameter 2) as well. Wetlands areas are minimal, yielding a wetland area and function score of 3/20 (parameter 11).

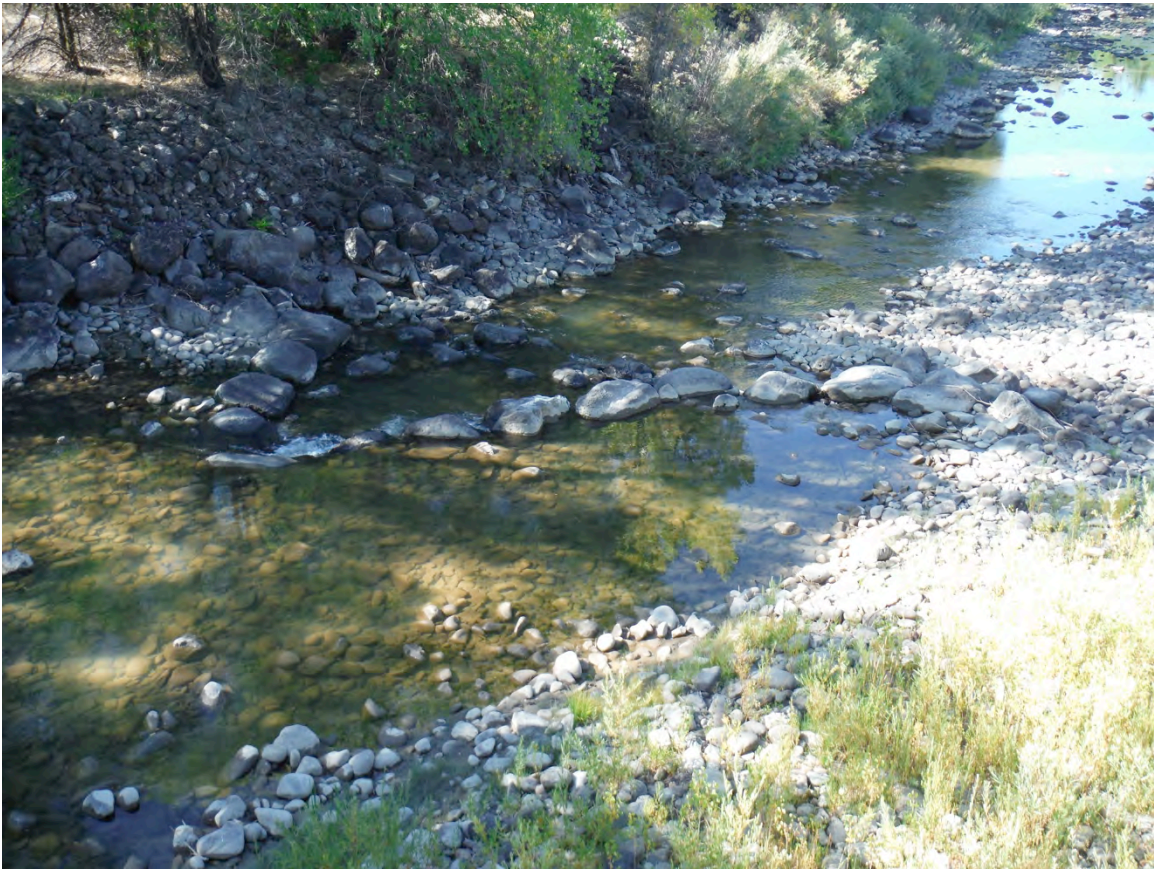
Photo 39. Paonia Sewer Crossing "W" Weir, 2014

The Paonia sewer crossing project succeeded in protecting the town's buried sewer pipe while making some slight enhancements to aquatic habitat quality. No additional restoration or maintenance activities are recommended at this time.
