**North Fork of the Gunnison River
Environmental and Recreation Needs Assessment**

December 2017

Including review of previous assessments, current stakeholder interviews, and recommended priorities aligned with newly developed river segments

Western Slope Conservation Center
PO Box 1612
Paonia, CO 81428

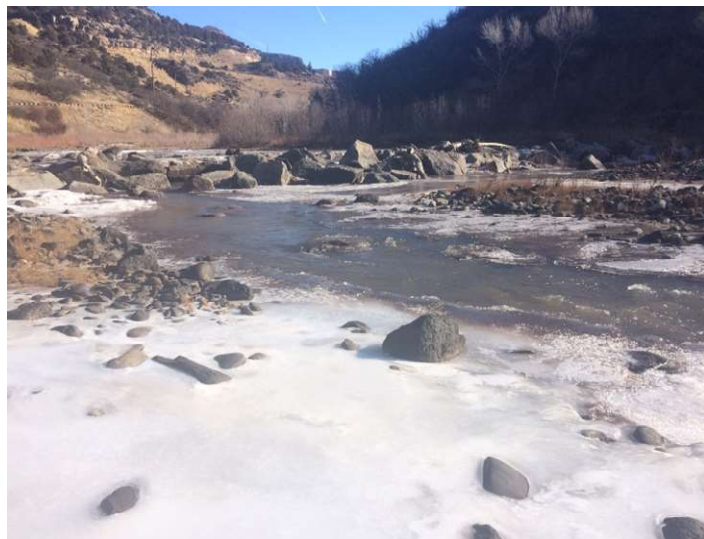
Fire Mountain Canal diversion structure represents a major hazard to boaters, at times rendering passage impossible. The river banks are quite steep surrounding the diversion, making it difficult to exit the river for portage. The diversion intake structure is equipped with a trash rack and floating boom that provides a good measure of safety for boaters unable to make a landing. Fish passage through this diversion is greatly impeded most times of the year. Passage is altogether eliminated during low summer and fall flows.

Fig. 3.2.3 Fire Mountain Canal Diversion, looking upstream

Morphologically, the timber wall structure and physical angle of Fire Mountain Canal Diversion to the river seems to be impeding bed load transport in the river through this area. A combination of these and the changes to river flow at the diversion is likely contributing to build up of a gravel bar directly upstream of the intake structure. Downstream of the Fire Mountain Canal diversion the river continues its natural, slightly entrenched, meandering, riffle/pool course. Although no semi-formal interviews were conducted within Reach 2, discussions with water users indicate that flows in this stretch could do support boater recreation well into the irrigation season. However, a lack of public property within this reach and limited public access from Highway 133 make boating problematic. As was the case in Reach 1, trespassing does occur by fisherman and boaters along areas that provide easy entry from Highway 133. Despite the lack of public access, there are minimal reports of conflicts between landowners and recreationists.

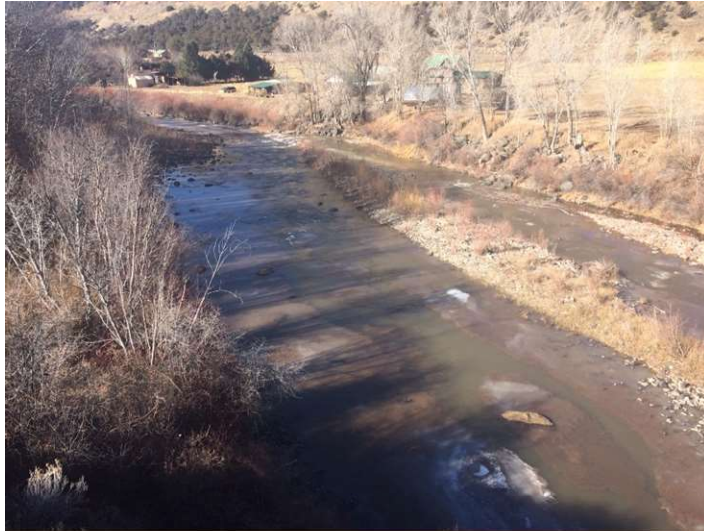
Fig. 3.3.3, Reach 3 near cross-section station 1, looking downstream

In 1996 and 1997, NFRIA installed “permanent benchmarks with survey pins and caps, driven flush into the ground with 6” of concrete poured around rebar on stable sites above the active channel” to mark cross-sections along a 16-mile study area to investigate the morphological characteristics of the river channel. (Crane. 1997) The most upstream permanent cross-section Station 1 is within Reach 3 and is located just upstream of the North Fork confluence with Terror Creek. At the time of the 1997 study, the river at cross-section Station 1 had “a very high width/depth ratio of 272 with a large mid-channel bar and a substantial cut-off channel on the north. The river meanders to the south with the apex of the

meander the cross-section. This reach has a moderate sinuosity of 1.31 and is slightly entrenched. Vegetative cover on the outside bank is poor with a bank hazard of very high. The channel material is classified as large cobble with a high bed load. The stream type is classified as an unstable C3.” (Crane, 1997)

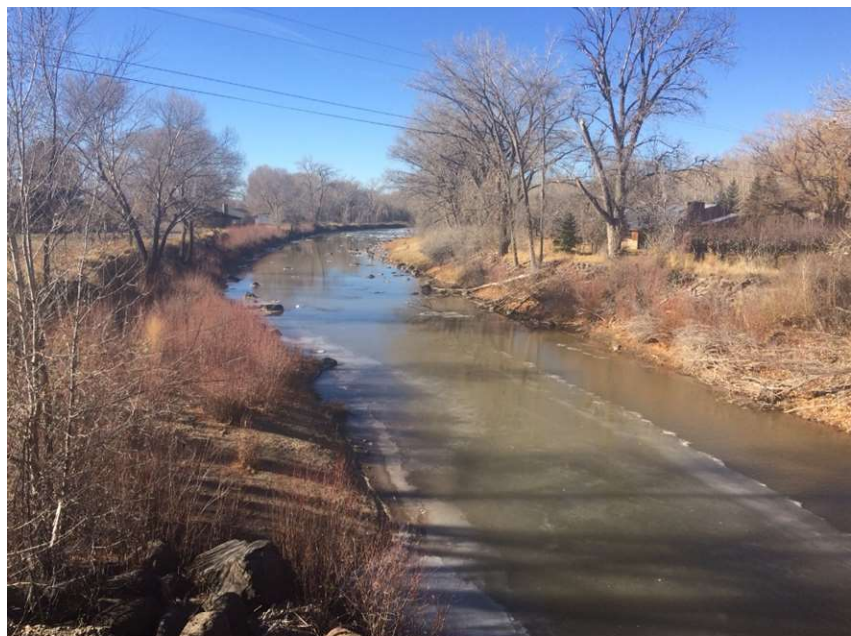
There are two significant obstacles to recreation within Reach 4. The first is that there is no public access along this reach. The second are the hazards associated with the North Fork Farmer’s Ditch diversion. North Fork Farmers is a check dam structure made of timber, rock and concrete, supported by a boulder field. High flows through the dam present a significant navigational hazard. Additionally, metal cribbing supporting the diversion structure protrudes above the concrete weir, posing an

Figure 3.4.2 Reach 4 near Black Bridge, looking downstream

extremely dangerous situation to floating watercraft. Furthermore, late in the irrigation season, the Farmer’s Ditch diversion tends to “sweep” the river, leaving the downstream bed void of any water for 0.3 mile before return flows re-enter the main channel. (NFWCD, JUB 2017) This presents an insurmountable barrier to boaters and aquatic species alike.

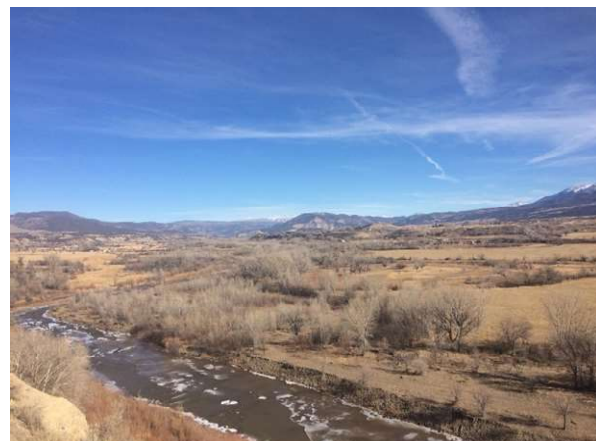
In 2005 this project was implemented to improve 1,600 linear ft of channel and adjacent riparian areas. The project included construction of a new channel to increase sinuosity, reduce grade, widened the riparian zone, and re-established a natural riffle-pool sequence for fish habitat. Large boulders were installed along outside bends of the new channel with typical J-hook structures to reduce bank erosion. Habitat was improved through cottonwood and willows plantings along the extent of the project. Russian Olive and Tamarisk were removed from within the riparian

Figure 3.6.3 Upper Curry Restoration Site, looking upstream

corridor and replaced with cottonwood and willow plantings. The project was highly successful and represents one of the larger intact riparian corridors along the North Fork. (Crane, 2014)

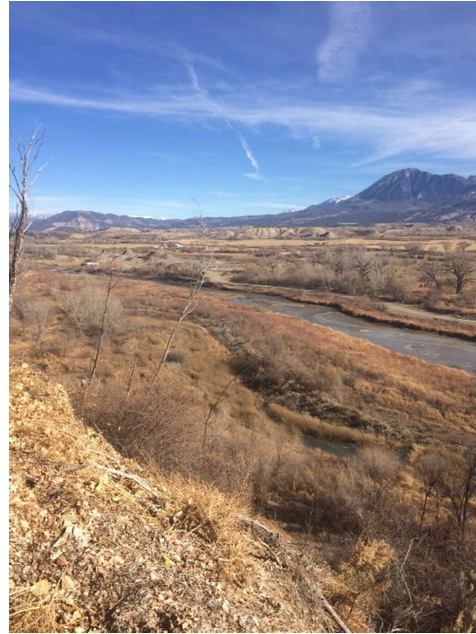
The Tri County Gravel pit is located at the upper end of Reach 7, and was the site of another in-stream gravel mine. (Figure 3.7.2) The pit ceased mining operations in the river channel in the late 1990's and has been operating out of the adjacent floodplain. A conservation easement was put in place to prohibit in-stream gravel mining in perpetuity. (Crane, 2014) WSCC is unaware of any other restoration projects that have taken place within this reach.

Impacts to the river channel from past mining continue to be evident. Permanent cross-section number 10 is located just downstream of the gravel pit. At the time of the 1997 geomorphological study, there was a constructed dike on the north side of the river that isolated the river from its floodplain and forced the river's high flows against the south bank. The result is a vertical south bank, nearly 15 feet high, that still remains. (Crane, 1997) There is a terraced floodplain above this bank. An examination of aerial photos indicates no bank movement evident since the 1997 report, and the steep bank appears to be stable. However, just downstream near the Smith and McKnight Ditch diversion, landowners report that the north bank of the river has eroded significantly in recent years.

Figure 3.7.2 Reach 7 across from Tri-County Gravel Pit, looking upstream

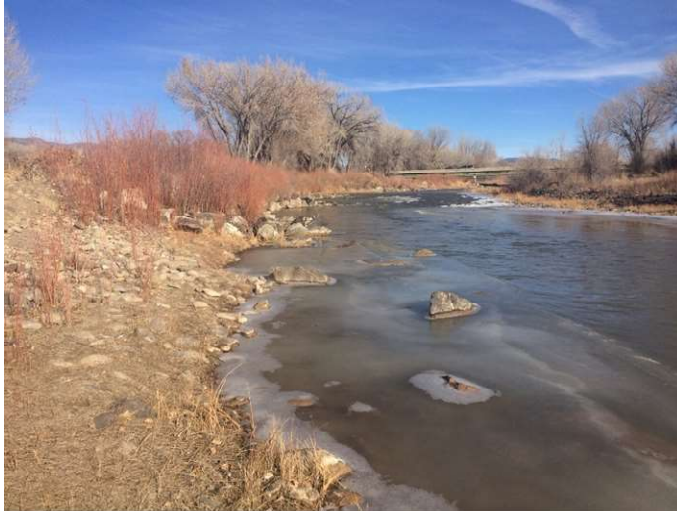
putting in at a low flat gravel terrace at the Delta County Fairgrounds. Delta County, WSCC, and other partners are currently in the process of gaining permitting and engineering to construct a formal river recreation access ramp. There is currently no signage to designate where the river access is located within the fairgrounds property. This has led to conflicts with an adjacent landowner when boaters inadvertently trespass on private property. One landowner has currently barricaded off the site to prevent further illegal access.

Figure 3.8.6 Reach 8 at Delta County Fairgrounds, looking upstream
