**Assessment of Aquatic Ecosystem
Restoration Projects**

1999 – 2014

**North Fork Gunnison River
Delta County, CO**

December 2014

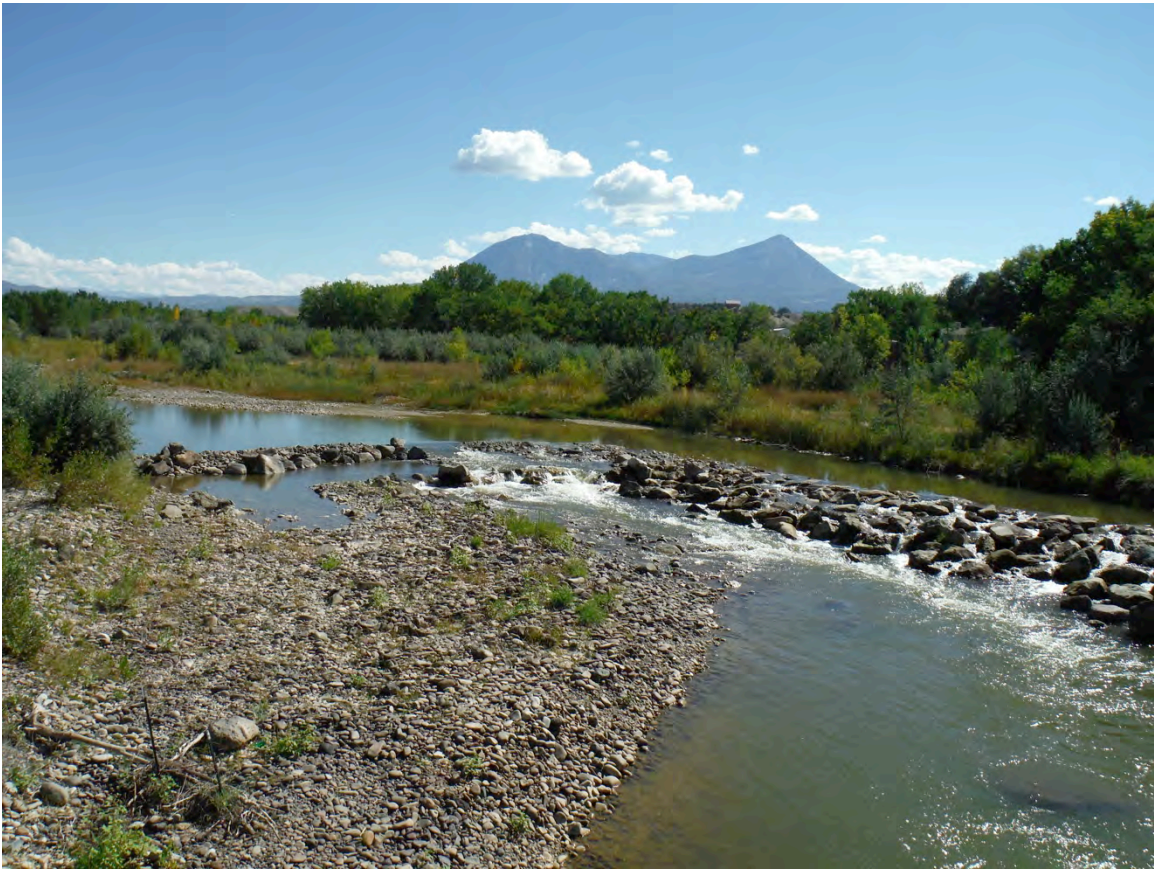
Photo 14. Smith-McKnight Ditch, 2014

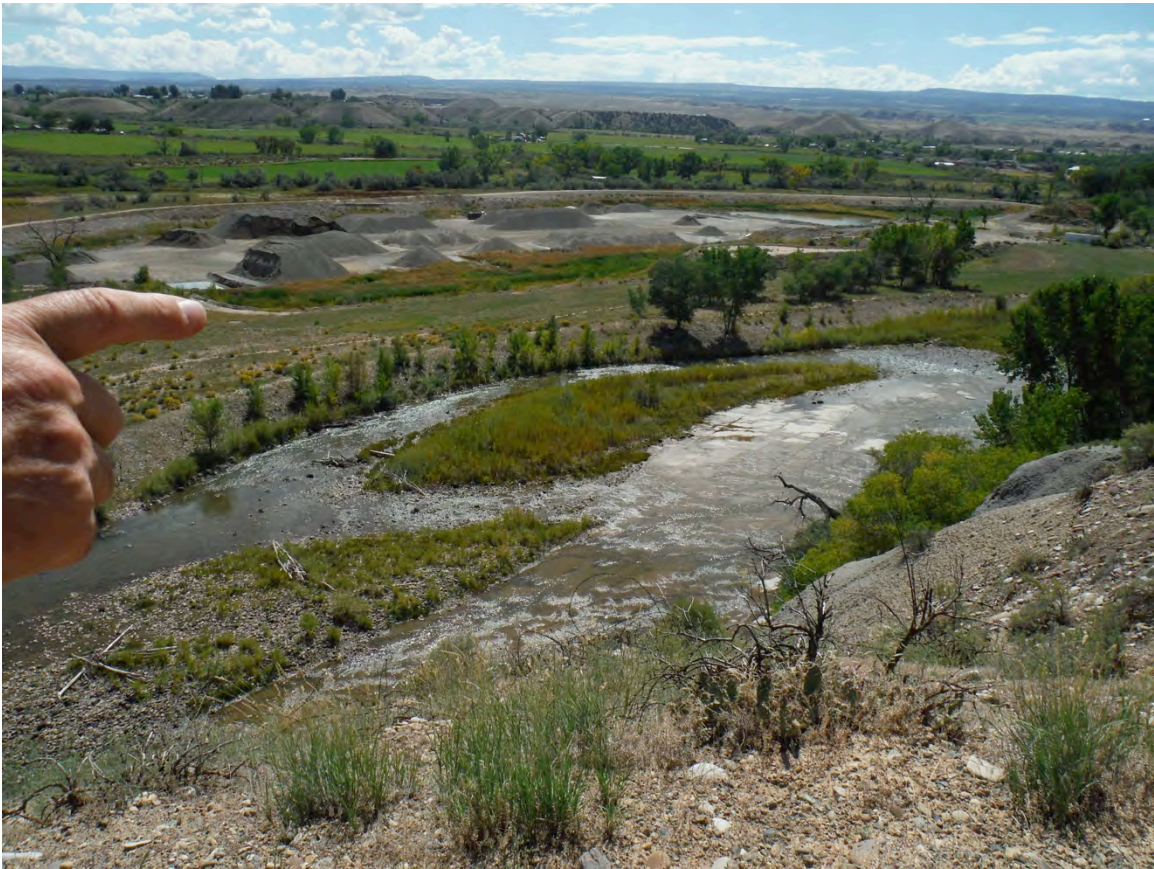
Photo 20. Tri-County Gravel Pit Blowout Location, 2014

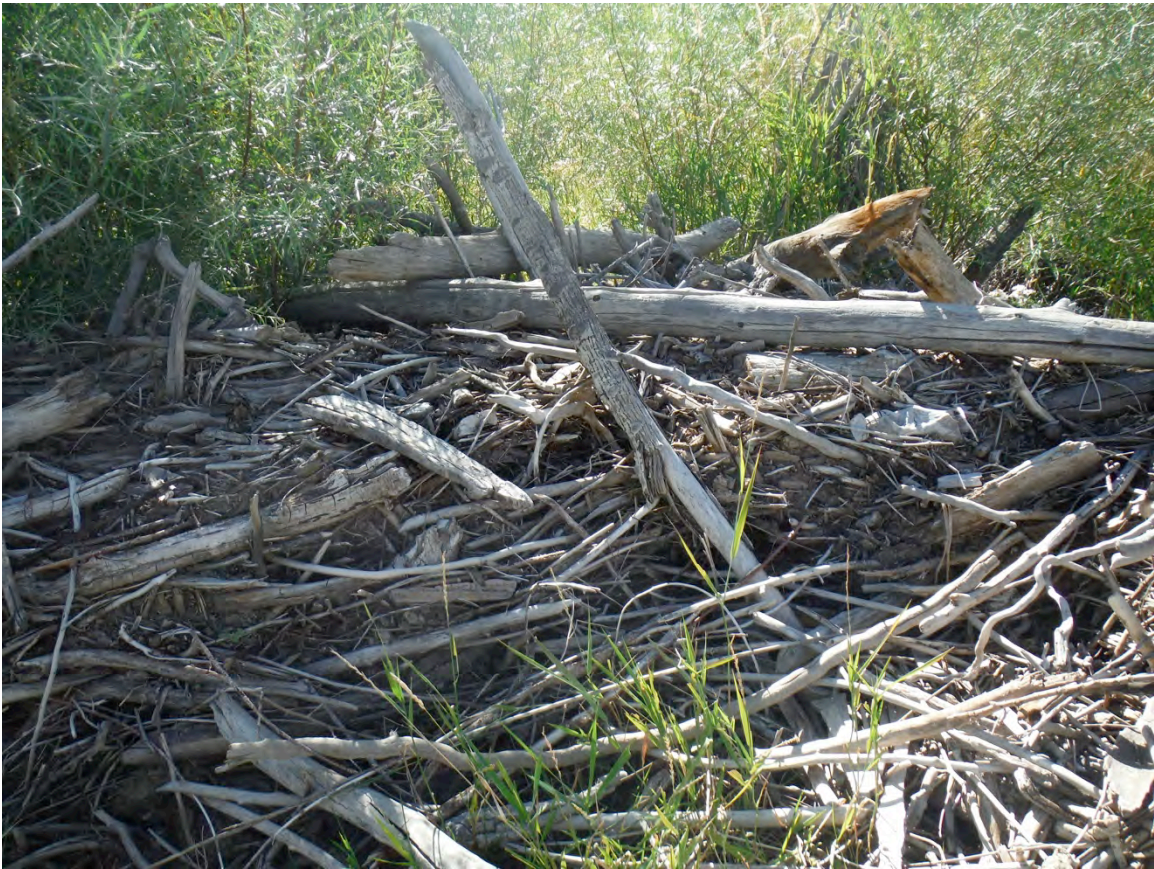
Photo 29. 2010 Midway Bank Stabilization Project, 2014

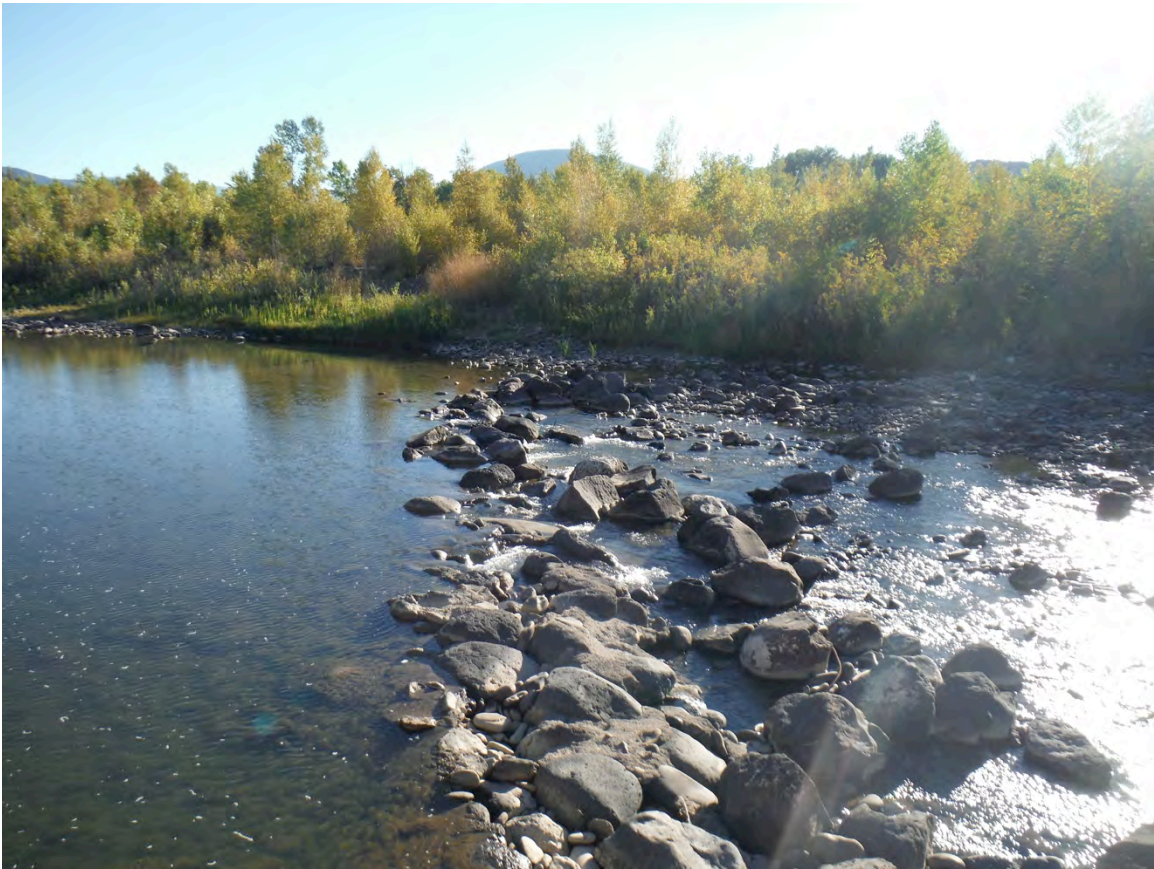
Post-project habitat quality scores are provided alongside pre-project scores in Table 13. Following the construction of a permanent irrigation diversion structure, the site achieved optimal ratings for 7 of the 11 habitat quality metrics: aquatic habitat barriers (16/20, parameter 1), aquatic structure as cover (16/20, parameter 2), velocity/depth regimes (16/20, parameter 3), bank stability (18/20, parameter 7), riparian vegetation cover (18/20, parameter 8), riparian vegetation structural diversity (18/20, parameter 9), and percent native woody vegetation (18/20, parameter 10). Photo 36 (Appendix B) shows a 2014 photograph of the grouted rocks emanating from the diversion point, as well as a healthy riparian vegetation community on the left bank of the river opposite the diversion structure.

Photo 36. Monitor Ditch Diversion and Left Bank Vegetation, 2014

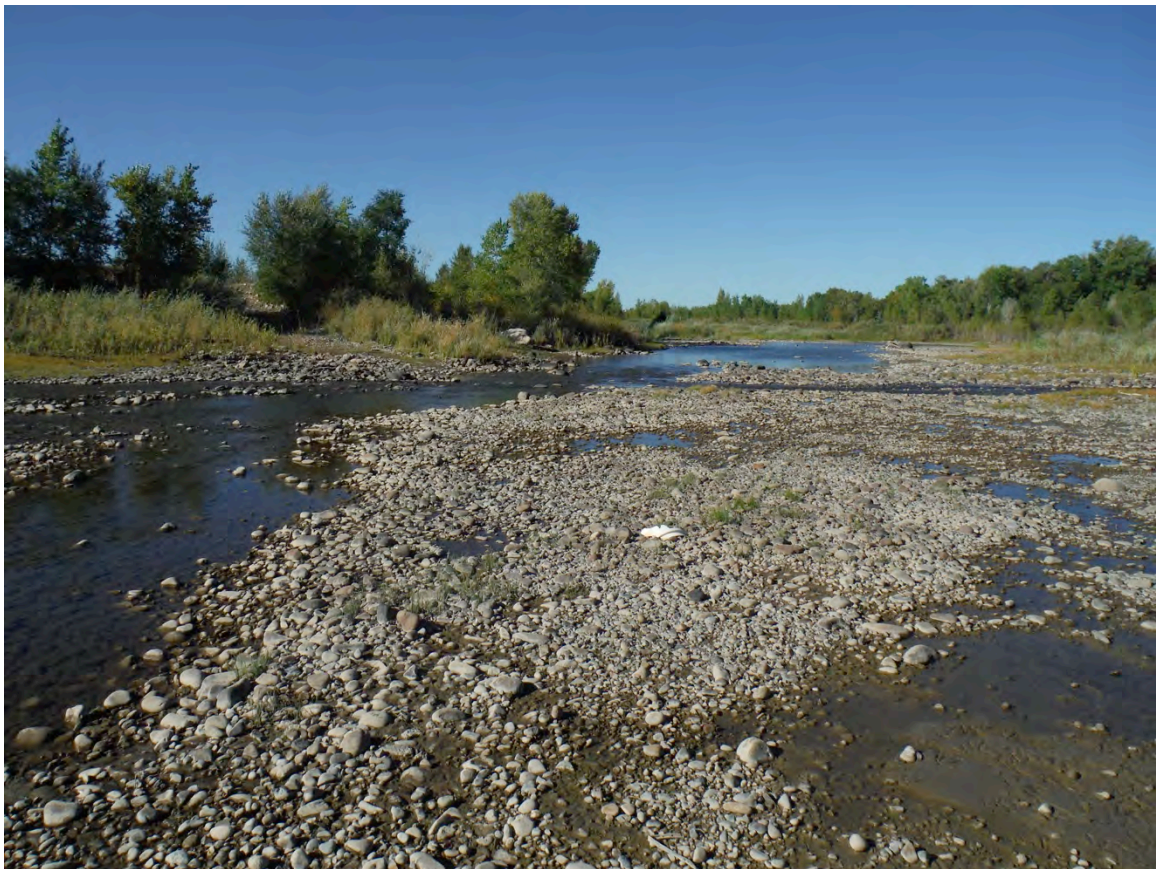
bulldozed and widened, and resembles a lentic environment instead of a lotic, flowing river (see Appendix B, Photo 37). As of 2014, the company appears to be mining on the left (south) side of the river, processing on the right (north) side of the river, and using a low-flow crossing to transport material from one side to the other. None of the area has been reclaimed and remains extremely shallow and wide (see Appendix B, Photo 38). The extremely high width-to-depth ratio has limited aquatic habitat in the area.

Photo 38. Wide Shallow Channel at Farnsworth Construction and Gravel, 2014

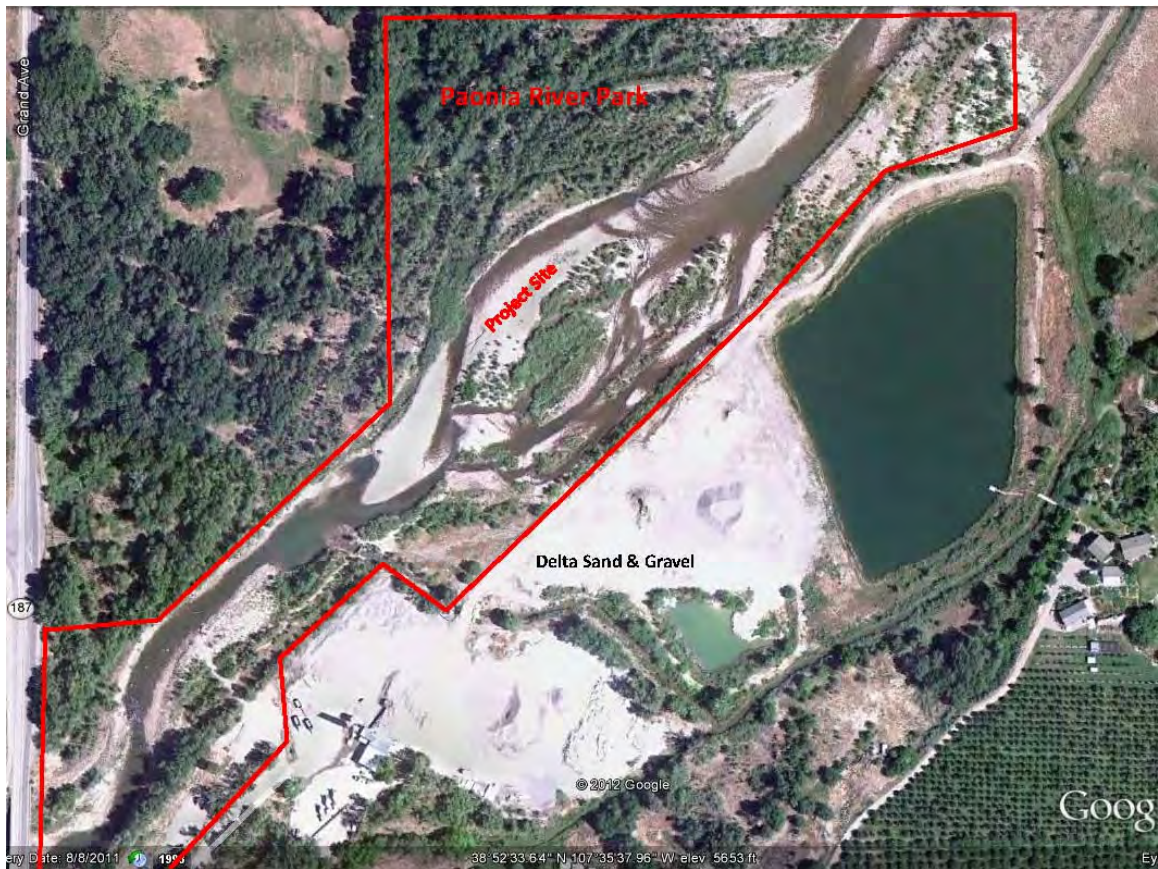
The Paonia River Park project aimed to turn the remnants of an in-stream gravel mine into a public park by reconstructing a floodplain from several braided channels and consolidating river flows into a single meandering channel, thereby enhancing both aquatic and terrestrial habitat. Appendix B (Photo 40) shows an aerial photograph of the Paonia River Park site prior to restoration activities. The 2012 project was designed to balance the bedload transport capabilities of the channel and enhance the morphological integrity of the ecosystem. Project design, implementation, and monitoring details, as well as an array of photographs, are provided in the Paonia River Park Final Report (WSCC 2013), and a short summary is presented here.

Photo 40. Paonia River Park Site Prior to Construction

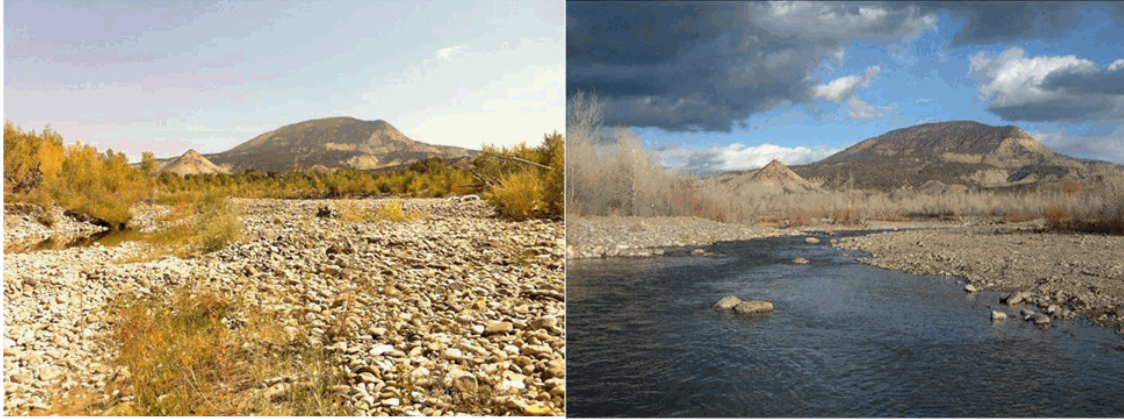
This project was implemented by reconstructing one of the braided channels into the primary channel and securing logs and woody debris in the secondary channels. The secured debris slows the velocity of water overtopping the bankfull elevation of the floodplain and allows the river to deposit sediment and its natural seed base onto the floodplain. This floodplain rehabilitation project utilizes the natural riverine processes to sustainably revegetate the floodplain. Refer to Appendix B (Photo 41) for a pair of Paonia River Park pre- and post-construction photo points.

Photo 41. Paonia River Park Pre- and Post-Construction Photo Points

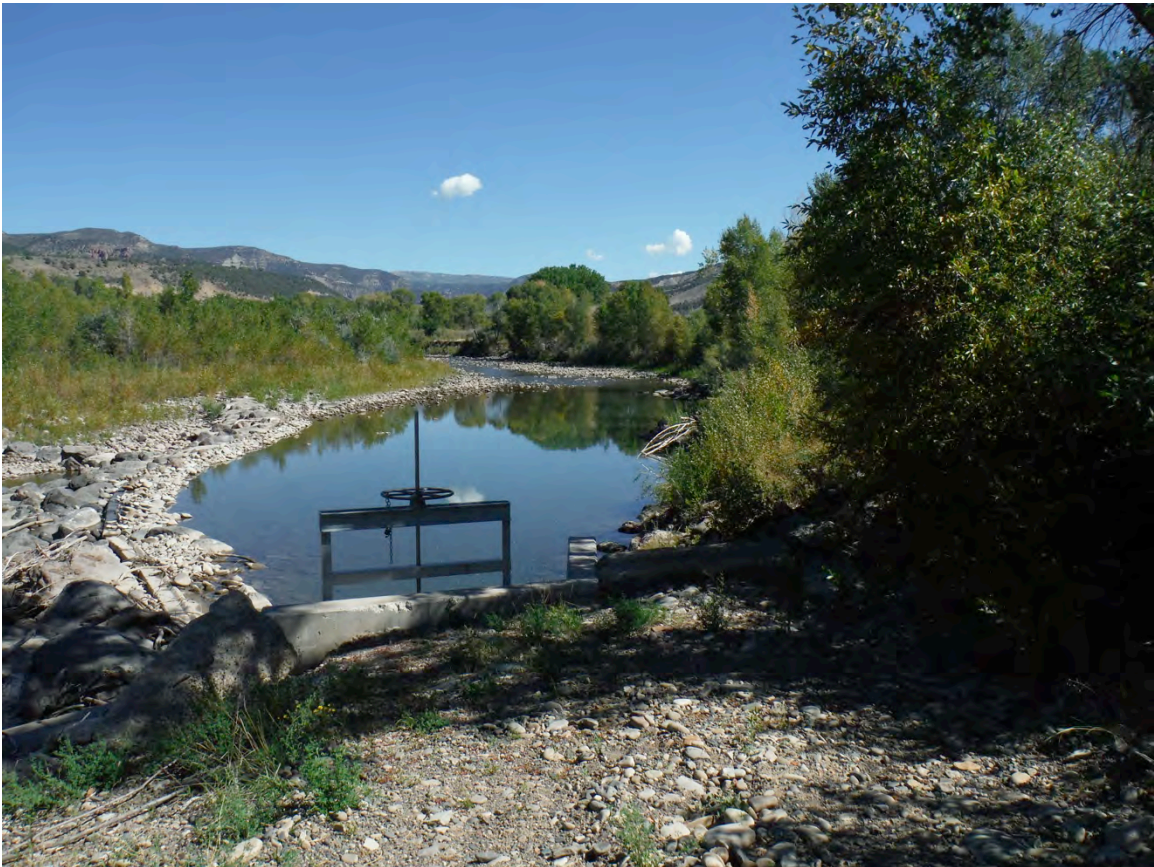
During high-flow spring runoff conditions following construction in 2008, the west end of the diversion structure on the opposite side of the head gate failed and washed out. NFRIA raised an additional \$12,000 to repair the structure where it had been compromised. However, the ditch company insisted on using the money to build a concrete and rock dam across the river with no low flow channel and no fish or recreational capabilities, negating the original goals of the project. The current diversion structure is pictured in Appendix B (Photo 43).

Photo 43. Paonia Ditch, 2014

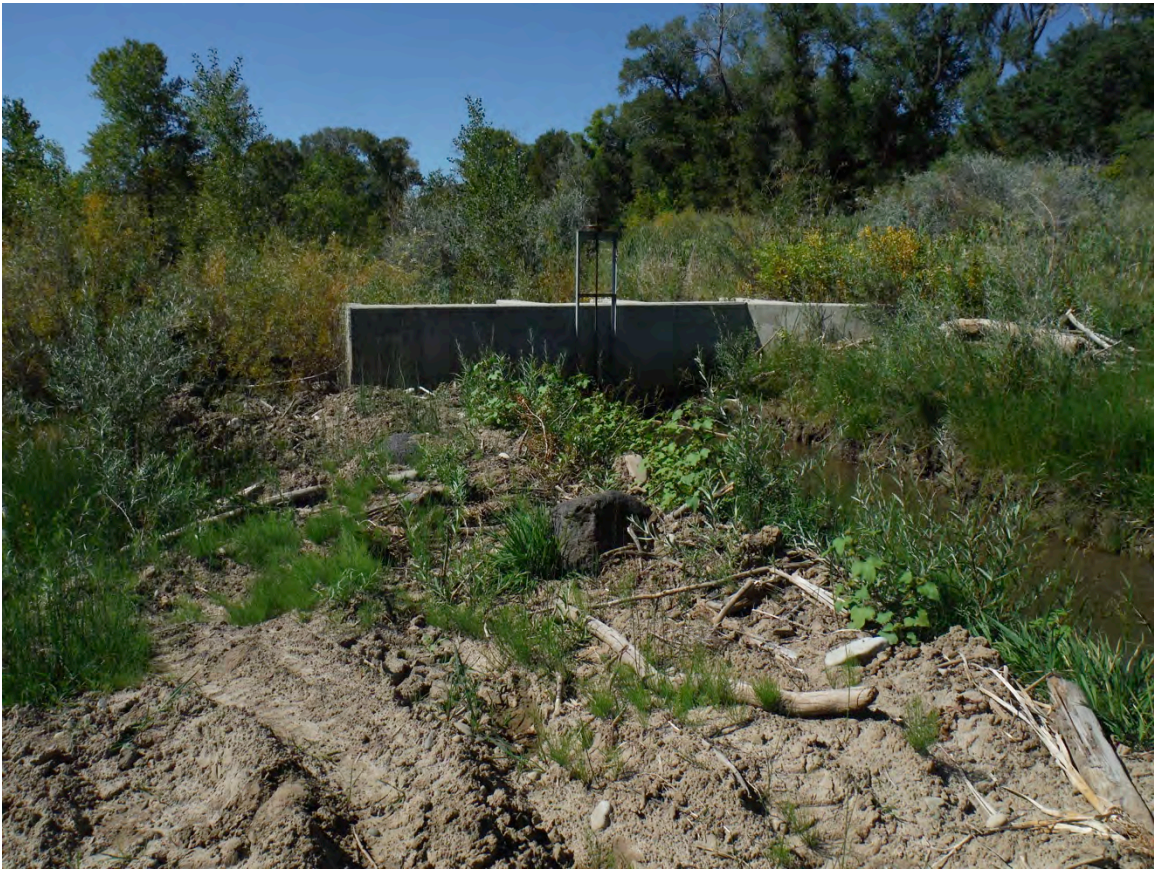
The Feldman Ditch was constructed in 2007 at the same time as the Paonia Ditch. The goals of the project were also the same as those for the Paonia Ditch (refer to Section 3.16.1), including reconstruction of an efficient diversion structure, enhancement of aquatic and terrestrial habitat, and promotion of safer recreation. The current diversion structure is pictured in Appendix B (Photo 44).

Photo 44. Feldman Ditch, 2014

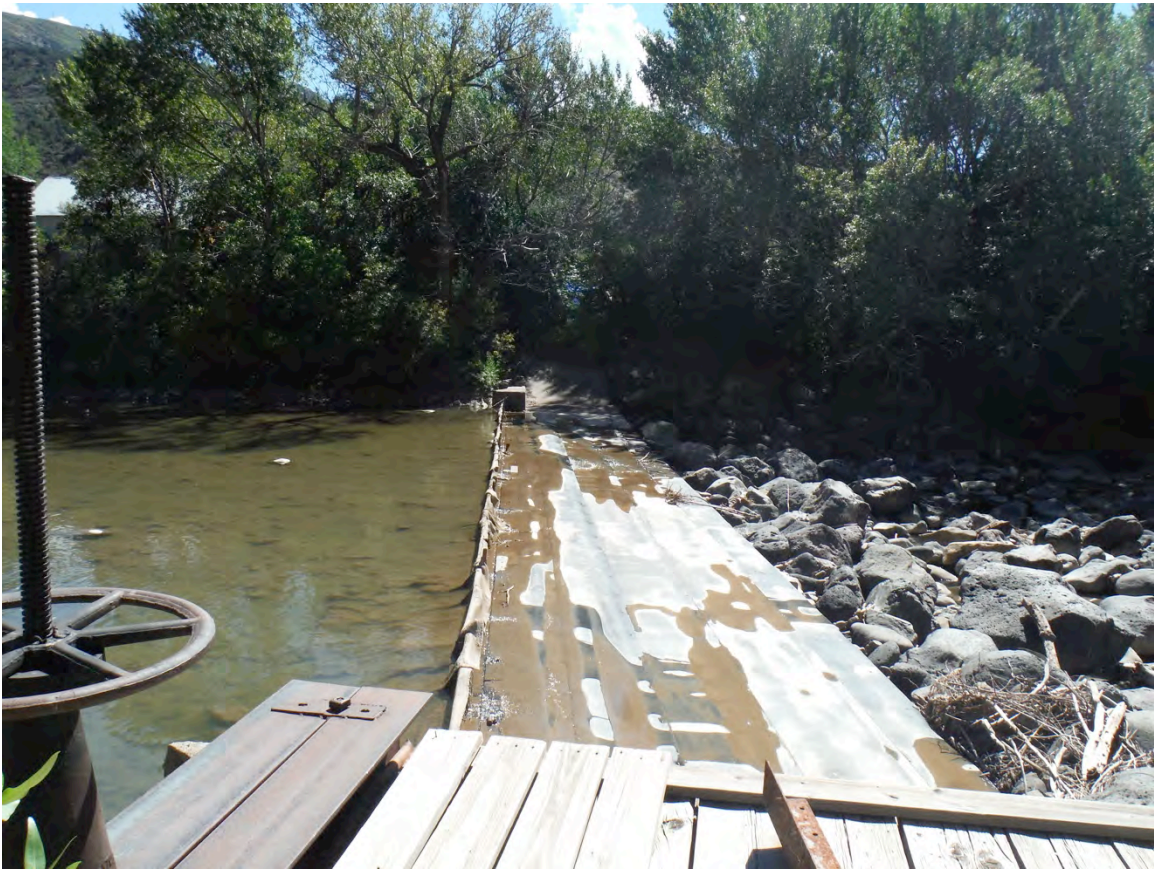
The Farmers Ditch (DPR Site 8) is located approximately 2 miles northeast of the Town of Paonia at a point where the North Fork parallels Highway 133 (Figure 1). The existing permanent diversion for the Farmers Ditch is essentially a 5-foot high check dam constructed of timber, rock, and concrete (Appendix B, Photo 45). The river upstream of the check dam occupies a stable meandering channel, and below the dam the river enters an entrenched straight channel narrowly confined by irrigated land on the left (south) and the Highway 133 embankment on the right (north) (USACE 2007). The structure diverts all of the water in the North Fork into the ditch, posing a barrier for fish movement during low-flow conditions and creating a safety hazard for recreational boating during higher flows. A restoration project at this location has been proposed by NFRIA but not conducted due to lack of landowner approval.

Photo 45. Farmer's Ditch, 2014

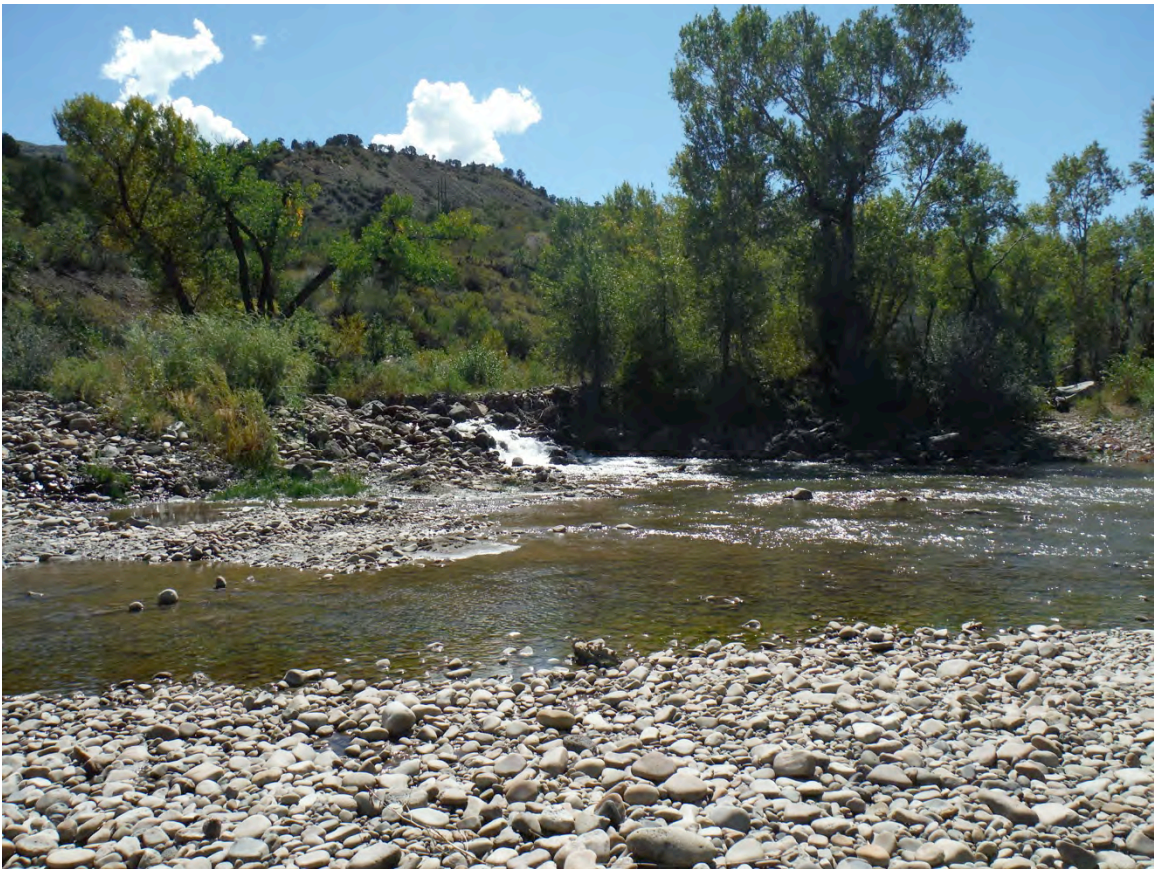
Appendix B includes three photos that depict the condition of the North Fork at the location of the Stewart Ditch. Photo 46 shows the makeshift head gate for the diversion structure in the back of the photo, with the actual main stem of the North Fork in the foreground containing water from groundwater and precipitation only. The left side of Photo 47 shows the water going through the ditch, divided from the essentially dry main stem of the North Fork on the right. Photo 48 depicts the North Fork's dry riverbed upstream of the diversion.

Photo 46. Stewart Ditch Diversion Headgate, 2014

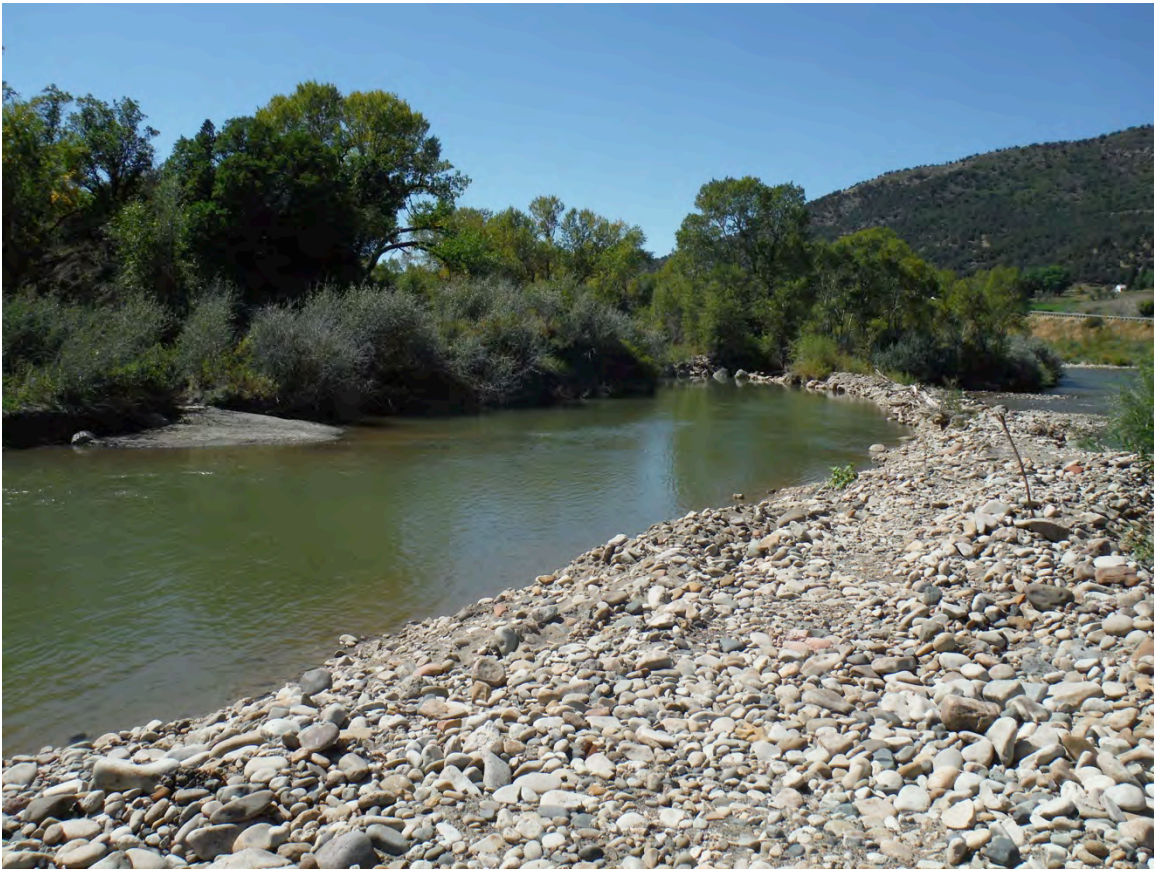
Photo 47. Stewart Ditch Diversion, 2014

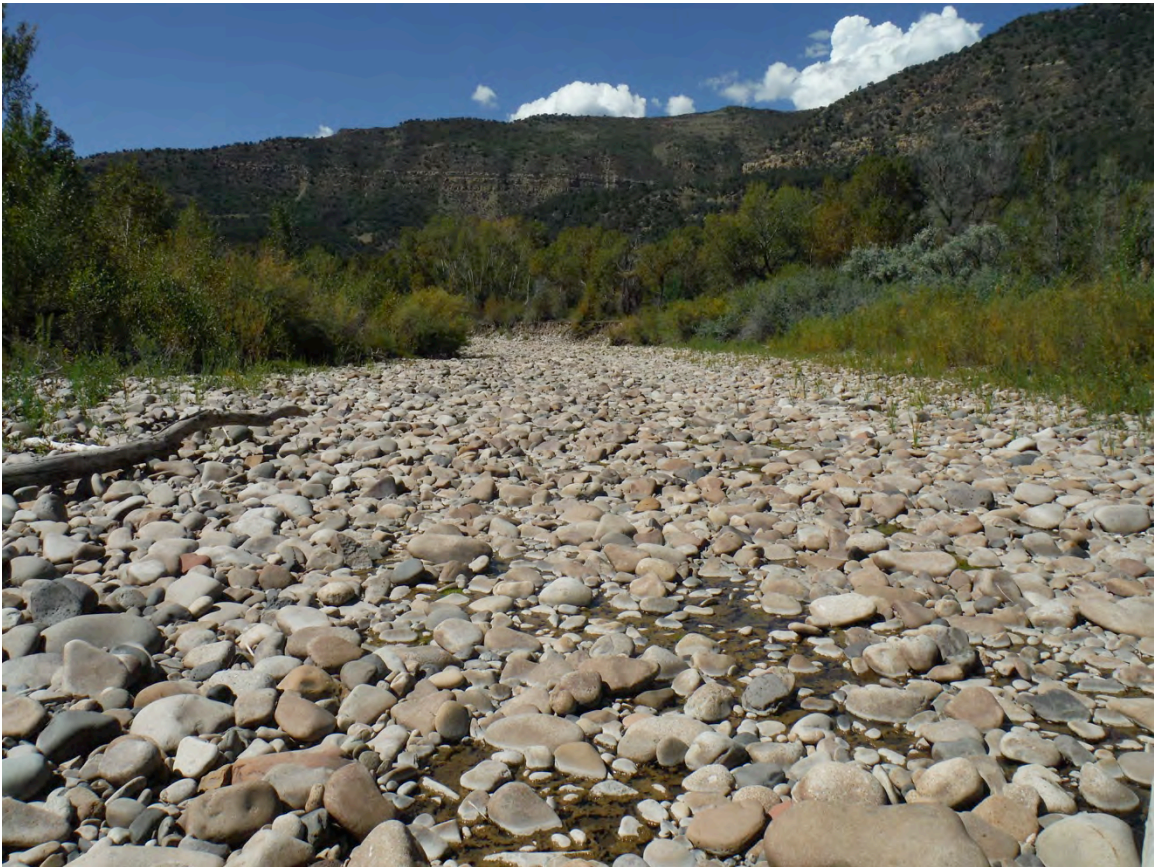
Photo 48. North Fork Main Channel Upstream of Stewart Ditch Diversion, 2014
