**North Fork of the Gunnison River
Environmental and Recreation Needs Assessment**

December 2017

Including review of previous assessments, current stakeholder interviews, and recommended priorities aligned with newly developed river segments

Western Slope Conservation Center
PO Box 1612
Paonia, CO 81428

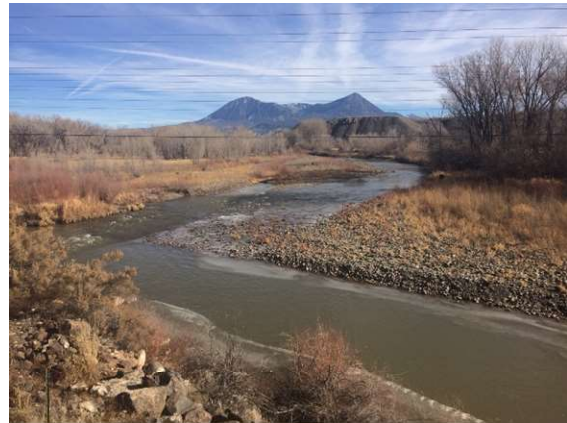
Figure 3.8.5 Reach 8, looking upstream at 3400 Rd Bridge

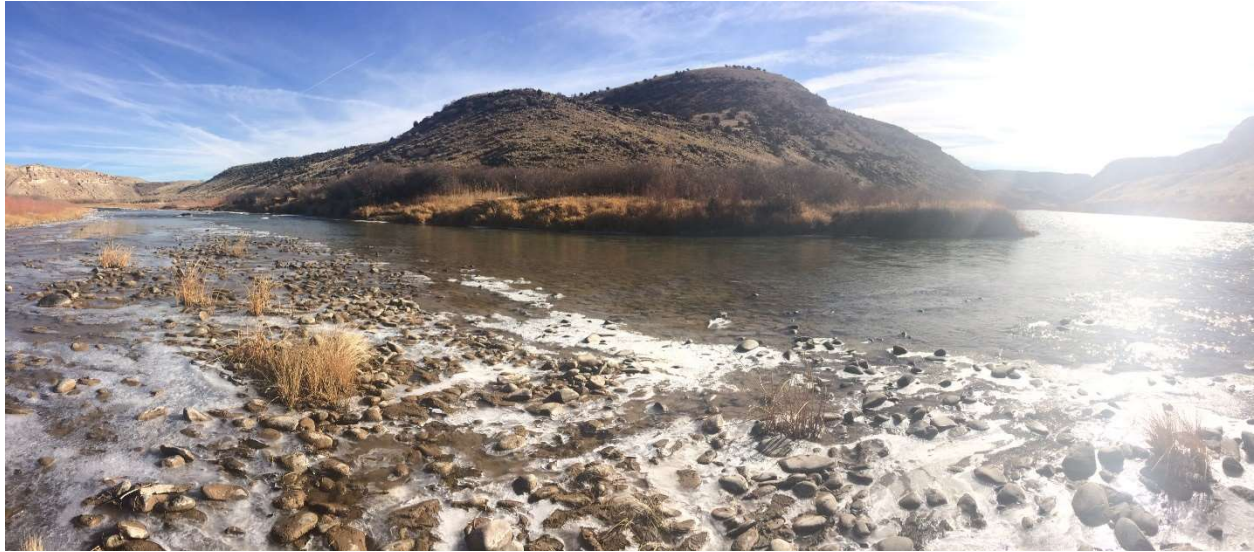
The North Fork continues its journey out of agricultural land and into a constricted canyon created by the base of Roger's Mesa on the north and high shale bluffs on the south. The riparian corridor is limited here by the steep natural banks. However, natural riparian function is maintained for the remaining section of Reach 8 until its confluence with the Gunnison River. Russian Olive and especially Tamarisk become more prevalent near the confluence of the two rivers.

Figure 3.8.8 Terminus of Reach 8, Confluence with the Gunnison River, North Fork on the left

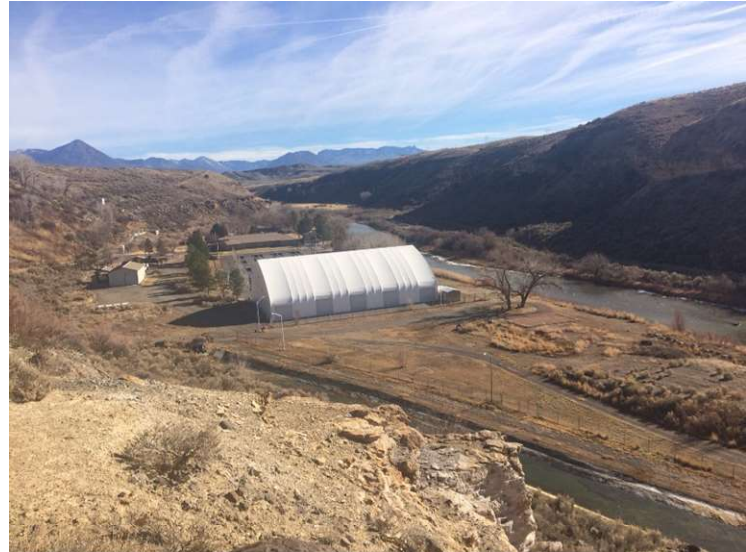
property and transport their vessels through the parking lot, inadvertently spreading river water through the hatchery facility. Contamination can also occur when fishermen walk up to tour the spawning beds after wading in the river. In 2015 the Hatchery had an outbreak of salmonid bacterial kidney disease. The Hatchery was forced to reduce their population by 50% and an estimated 1.5 million dollars was spent between Hotchkiss and other hatcheries in the west to remove the infection. The contamination came from a batch of infected fish from a state Hatchery in Glenwood Springs but nevertheless, the Hotchkiss facility is very sensitive to disease contamination from any source.

Figure 3.8.7 Reach 8 at USFWS Hotchkiss National Fish Hatchery, looking upstream
